DEVELOPMENT OF URANIUM DIOXIDE —
TUNGSTEN CERMET FUEL SPECIMENS
FOR THERMIONIC APPLICATIONS

by P. J. Gripshover and J. H. Peterson

Prepared by
BATTELLE MEMORIAL INSTITUTE
Columbus, Ohio
for Lewis Research Center

NATIONAL AERONAUTICS AND SPACE ADMINISTRATION • WASHINGTON, D. C. • JULY 1968

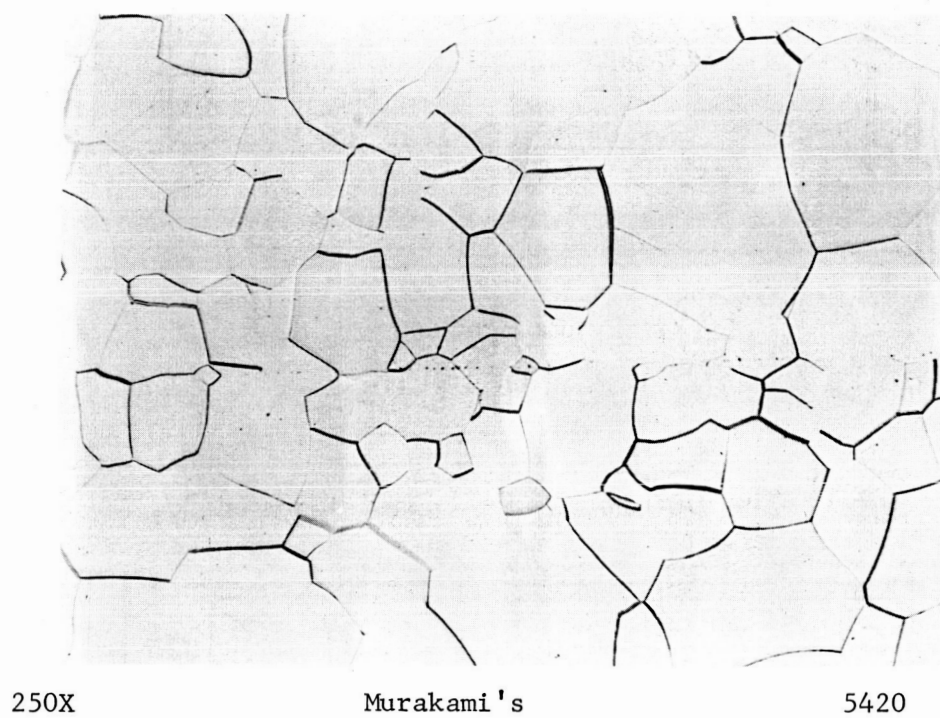
FIGURE 2. TUNGSTEN JOINED BY GAS-PRESSURE BONDING

These polished surfaces were bonded at 2900 F and 10,000 psi for three hours.

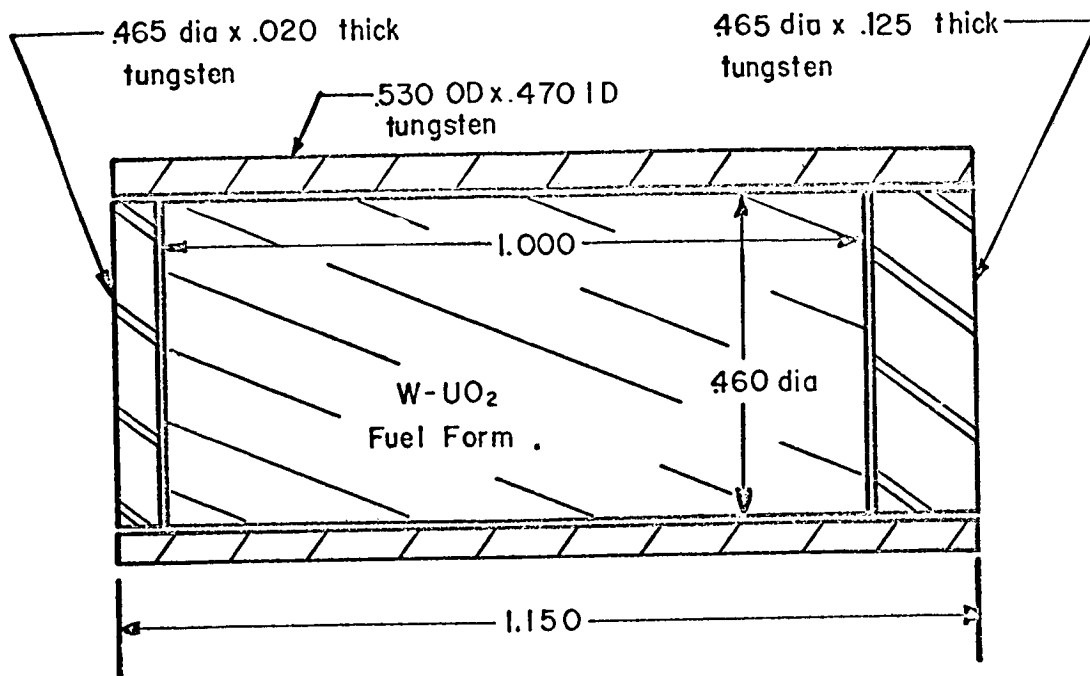
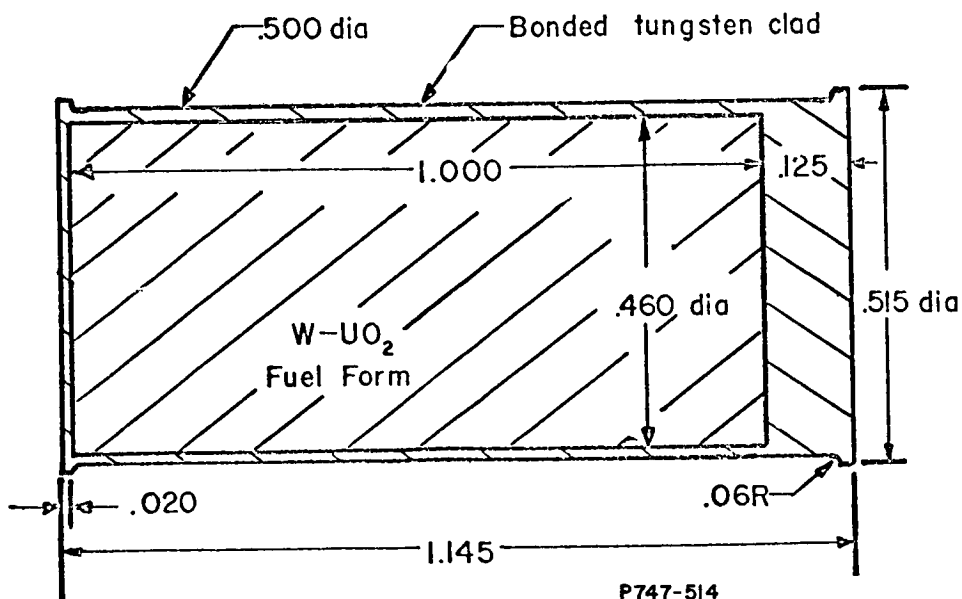
FIGURE 3. CLAD FUEL PELLET

a. Before Bonding

b. After Bonding and Grinding

Initially, the cladding components were machined to the dimensions shown in Figure 3. This shows a clad fuel pellet prior to bonding. The desired pellet size after bonding is shown also in this figure and would be achieved by grinding the OD and any excess from the ends of the tube. It was anticipated initially that no machining of the fuel form would be required. The hole through the center of the tube was accomplished by electrical discharge machining. The end plugs were ground to 0.465 diameter from 0.125-in. and 0.020-in. tungsten sheet material. All tungsten was vacuum arc cast rather than powder metallurgy stock and met the 99.97 percent purity specifications.

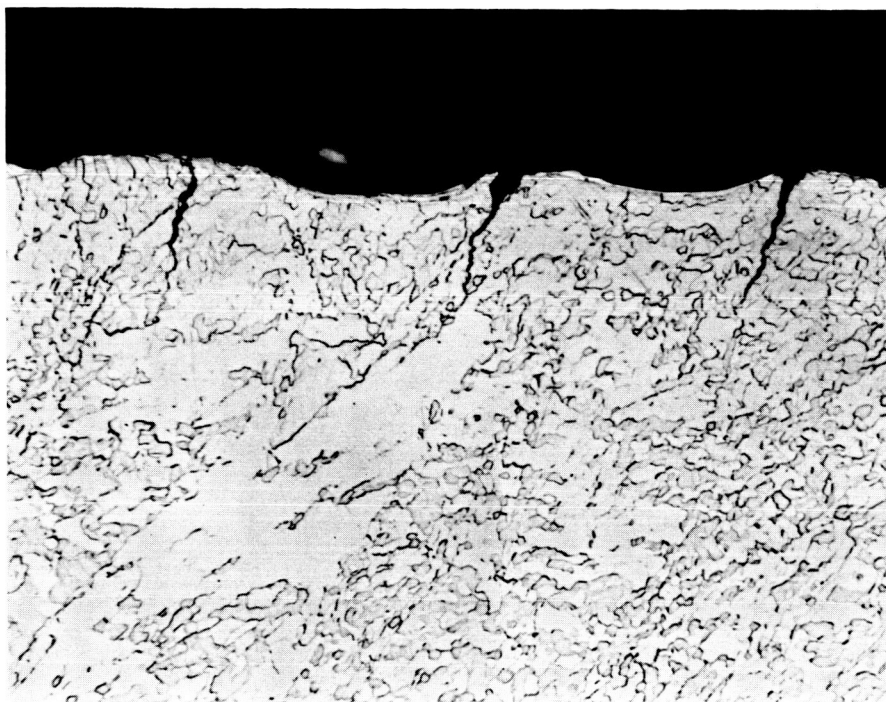
FIGURE 4. CRACKS IN TUNGSTEN CLAD RESULTING FROM
ELECTRICAL DISCHARGE MACHINING

As work progressed on the program and failure mechanisms for the cracking of the cladding material were investigated, it became apparent that the electrical discharged machined surface contained microcracks. This is shown in Figure 4. Although these small cracks may heal during gas-pressure bonding,

these could well be sites where cracking during thermal cycling could initiate. To remove these cracks and also provide a smoother surface for bonding, the tubes were EDM'd undersize and then honed to final size. A minimum of 0.005 in. was removed from the surface to eliminate these cracks. A 2500 F stress relief was also found to be beneficial prior to honing to minimize the tendency of crack propagation. It was also found desirable to reduce the clearance between the clad and the pellet to minimize the deformation required to achieve intimate contact between all components. Another improvement that evolved from this work was to make the end plugs thicker than required and the tube longer than required so that the ends of the pellet could be ground to remove any evidence of the bond interface. A drawing showing the cladding dimensions is shown in Figure 5. The final dimensions of the pellet are also shown.

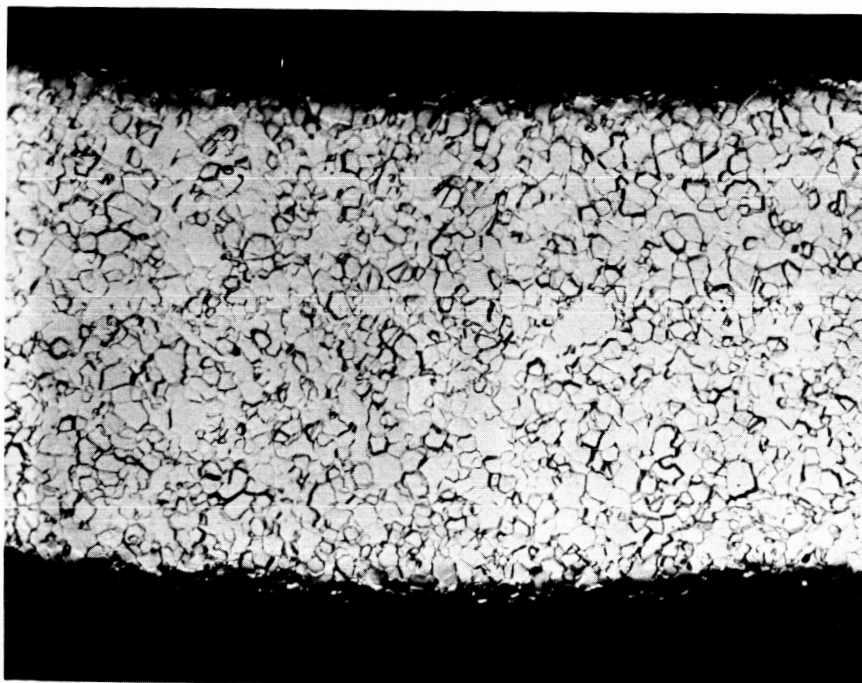
FIGURE 6. EXTRUDED TUNGSTEN TUBE

This tube has been subjected to
five thermal cycles to 1800 C.

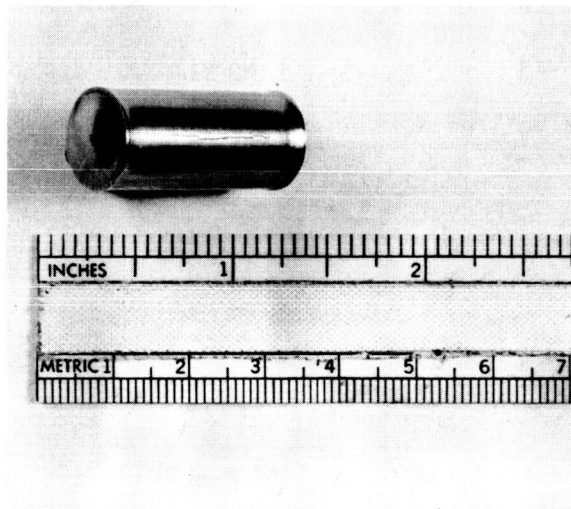
FIGURE 12. SPECIMEN AFTER FIVE THERMAL CYCLES

This specimen showed no defects after one thermal cycle.

Since the xyglo and helium leak check tests showed no cracking, the pellets were submitted to four additional cycles. Upon inspection, longitudinal cracking was apparent in both specimens. The blistered pellet had two such cracks as well as a transverse crack in the area where the core meets the 1/8-in. end plug. Almost complete separation of the thin end plug from the tube had occurred. The other specimen possessed three longitudinal cracks. These specimens are shown in Figures 12 and 13.

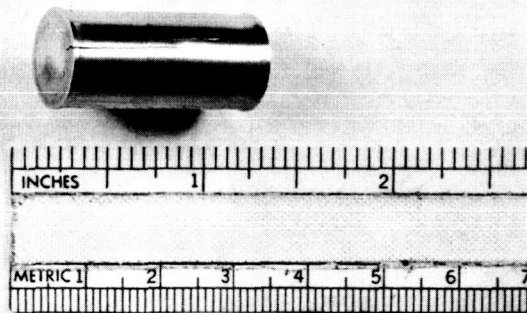
FIGURE 13. SPECIMEN CONTAINING DEFECT AREA AFTER FIVE THERMAL CYCLES

Note the lack of bond between the end plug and the tungsten cladding.

After the first cycle, one specimen showed no change while the other specimen, which showed the defect initially, had a 40-mil blister on the 20-mil end plug end. In addition, the original defect area was slightly enlarged.

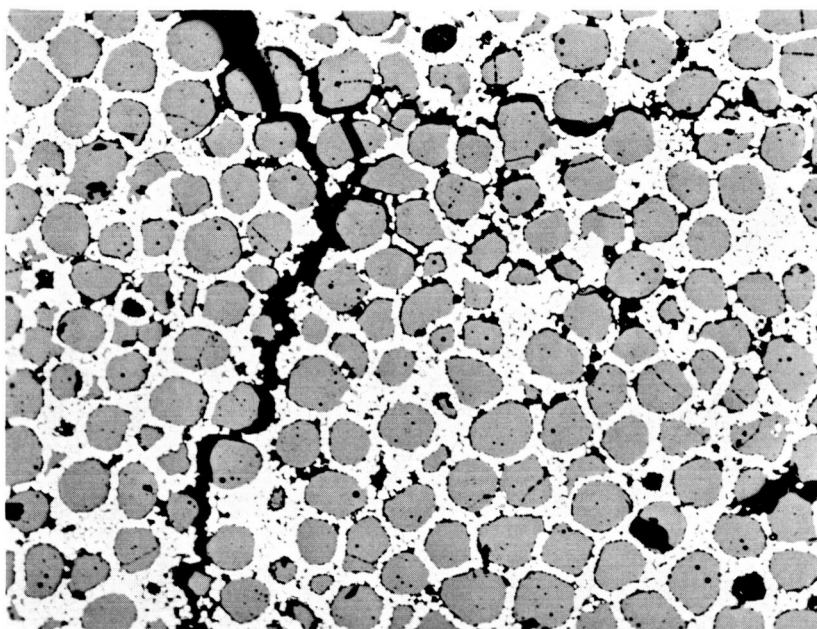
FIGURE 14. CRACK IN FUEL FORM AS A RESULT OF THERMAL CYCLING

This is the specimen shown in Figure 12.

Metallographic sections of these two specimens were made transversely through the center of the specimen and longitudinally through the remaining end pieces. Evaluation of these sections showed extensive intergranular fracturing of the core in both the UO_2 and the tungsten. Cracks that were observed on the surface of the pellet penetrated the core. A photomicrograph of a crack into the fuel form is shown in Figure 14. Small cracks initiating on the inside surface of the clad tube were noted as shown in Figure 15.

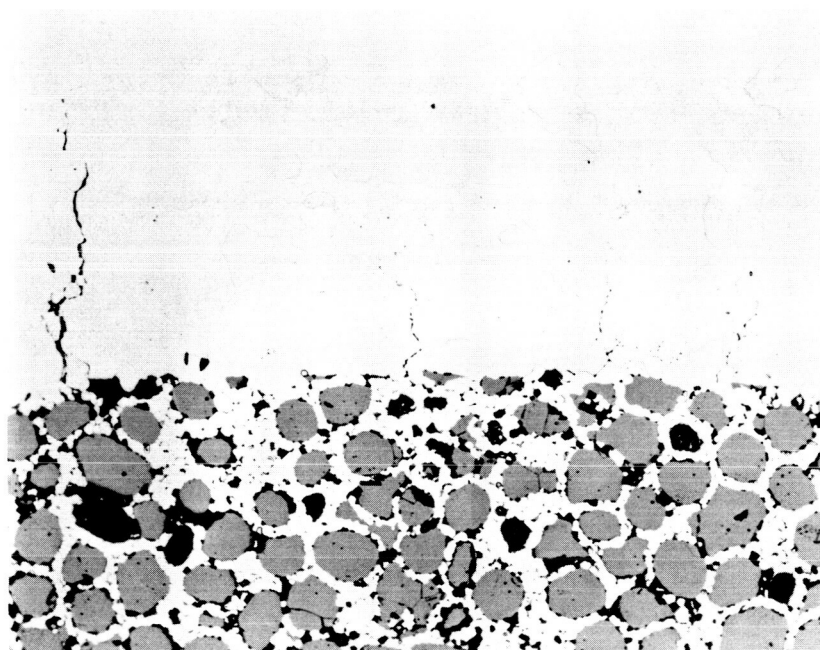
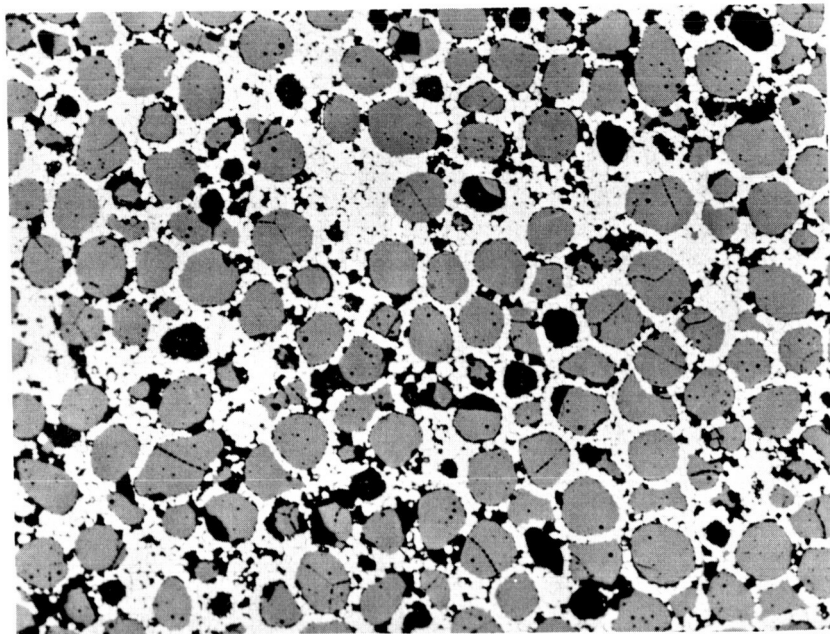
FIGURE 16. COMPARISON OF FUEL FORM MICROSTRUCTURE
BEFORE AND AFTER THERMAL CYCLING

a. Fuel Form Not Thermal Cycled.

For comparison, the as-bonded pellet was sectioned to obtain initial conditions of the clad pellet. The core did not appear to densify an additional amount during the cladding operation but the UO_2 itself did. Good core-to-clad bonding was observed while clad-to-clad bonds were only fair. Very fine grain size was found on the exterior half of the tube whereas large grains were observed on the interior half. Photomicrographs of the fuel form which was not thermal cycled and a fuel form after cycling is shown in Figure 16.

Analysis of these results prompted the thermal cycling of a tungsten cladding tube and an unclad fuel pellet. After cycling, these components were examined metallographically. No cracks were found in the fuel form and the degree of core disintegration was less than had been noted with the cycled clad fuel pellets. Microcracks were apparent on the ID of the tungsten tube. Further examination of other tubes indicated that these microcracks were caused by the electrical discharge machining of these tubes. No dimensional changes were noted in either components but a weight loss of 0.28 percent was observed in the fuel form as a result of the five thermal cycles.

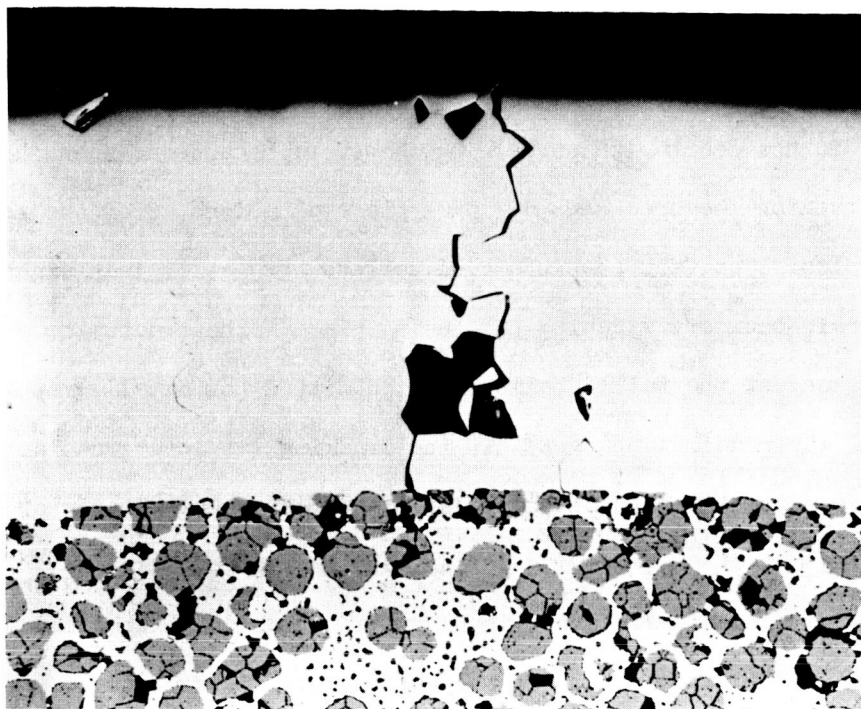
FIGURE 17. TRANSVERSE SECTION OF CLADDING FAILURE

One of the failed pellets was submitted for metallographic examination. It was readily apparent that the cracking was intergranular in nature. To point out the weakness of the grain boundaries, whole grains of tungsten were pulled out of the cladding during metallographic polishing. Both the cracking and pull-out are shown in Figure 17 which shows the cladding in a transverse section. Notice that to the right and left of the crack are grain boundaries which appear to have voids along a certain length. These are more clearly shown in Figure 18. These voids were examined at high magnification under bright and polarized light to determine if they were actually voids or microscopic inclusions of some sort. All areas examined proved to be voids. There is no doubt that these small voids represent the early stages of the intergranular cracking. The mechanism by which these voids are formed is not known thoroughly, but it is probably related to vacancy diffusion and the grain-boundary widening effects observed in tungsten of large grain size.

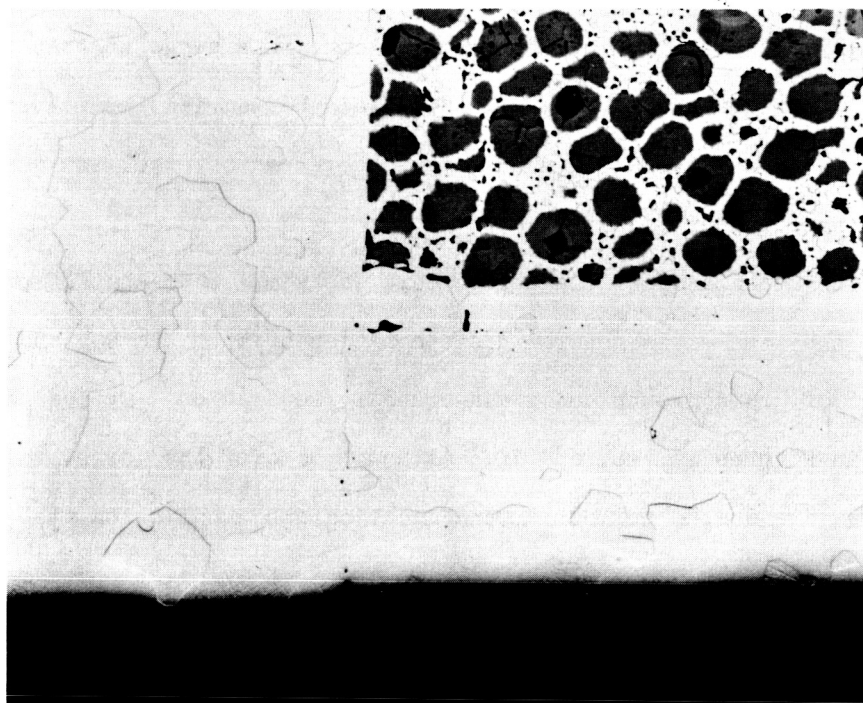
FIGURE 19. LONGITUDINAL SECTION OF BOND IN AS-BONDED PELLET

With regard to the clad bonding, satisfactory leak-tight bonds were produced during the pressure bonding cycle. Although some isolated voids still remain along the original interface, as shown in Figure 19, grain growth provided a gas-tight seal. Figure 20 is a photomicrograph of a bond after thermal cycling. Notice that although the voids are still present, no cracking occurred along this plane. Since the pellets grew

dimensionally by about 1 percent during cycling, this suggests that the bond line is not weaker than the tungsten grain boundaries themselves. In addition, the bond between the clad and the core was of excellent quality and showed no signs of failure.

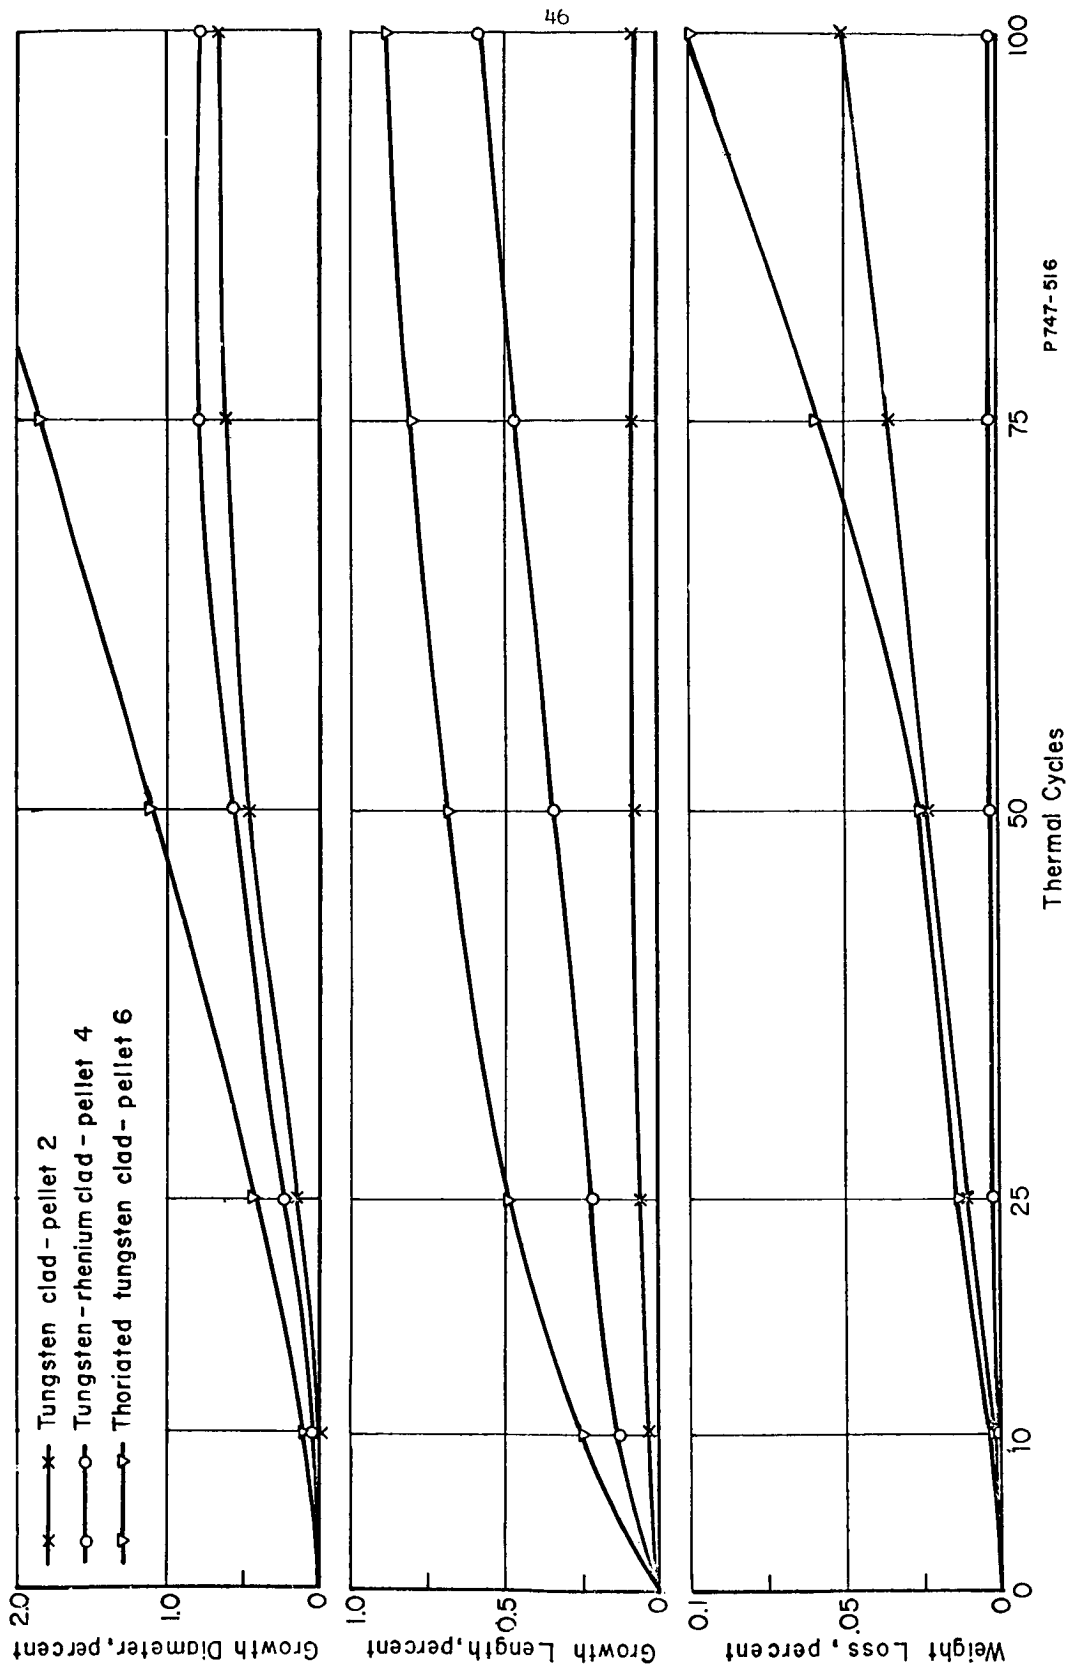
FIGURE 21. PERCENT GROWTH AND WEIGHT LOSS CURVES FOR THIRD THERMAL CYCLE EXPERIMENT

The growth produced in the lengths was somewhat different. In all three cases, the rate of growth decreased after the initial cycles as shown by the second set of curves in Figure 21. The tungsten-clad pellet (2) exhibited the least amount of growth with the majority being produced during the first two cycles. By the end of the tenth cycle, the pellet grew at a rate of about

The last set of curves in Figure 21 shows the accumulative weight loss of the three pellets. As shown, Pellet 4 had a negligible loss. It should be noted here that these percent values were calculated on the basis of the weight of the whole pellet both core and clad. The weight-loss curves are to show qualitative results only. However, they are indicative of the quantitative results since the weights of all three core pellets were within 0.3 percent. Percent loss calculated on the basis of the core weight will increase the values on these curves by a factor of about 1.55. Pellets 2 and 6 had almost identical losses until about the fiftieth cycle. Then, Pellet 6 began to lose at a much faster rate. This is evidently due to the cracking of the clad and resulting exposure of UO_2 to the vacuum.

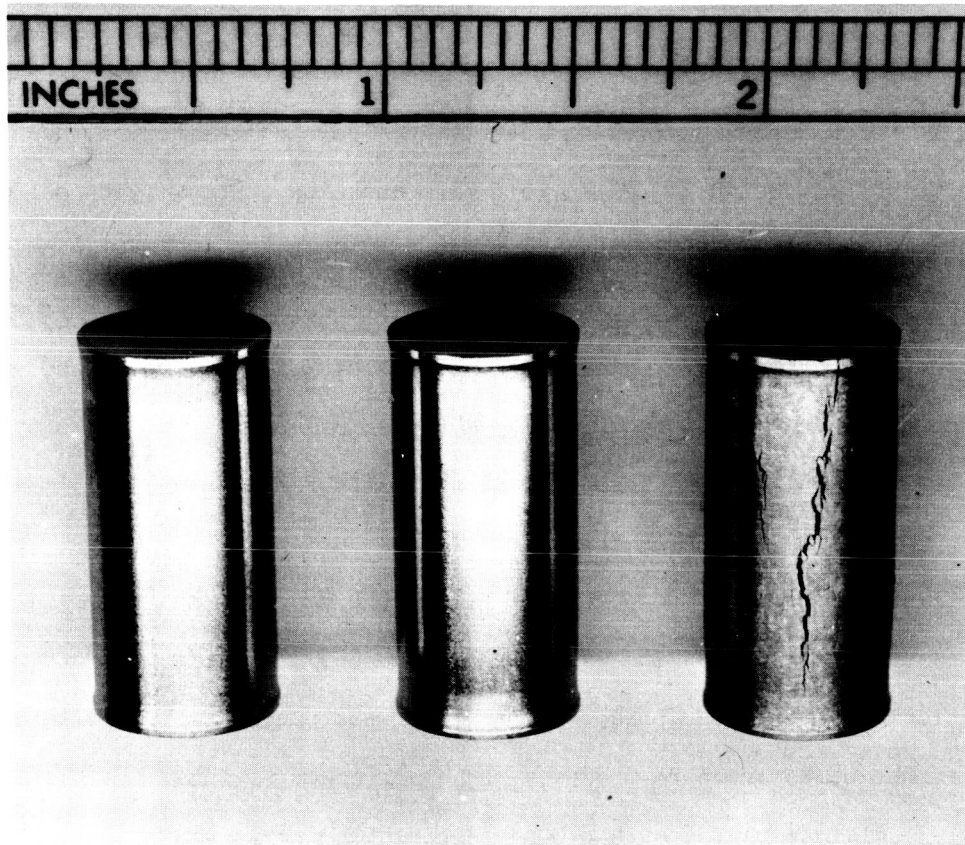
FIGURE 22. CLAD FUEL PELLETS AFTER 100 THERMAL CYCLES

Figure 22 shows the exterior of the thermal-cycled pellets prior to sectioning. Metallographic examination of the tungsten-clad pellet (2) revealed the best structure produced on this program to date. As shown in Figure 23, disintegration of the UO_2 and tungsten matrix was much less than in previous specimens. The UO_2 grain boundaries were not enlarged nor was there extensive pullout at the UO_2 -tungsten interface. Figure 24 demonstrates the excellent core-to-clad bonding which was achieved. Similarly, Figures 25 and 26 show the bonds produced between the cladding components. Although some spherical isolated voids existed at the interface, there was no indication of these creating a path for crack propagation.

Pellets 2 and 4 did not change in physical appearance at all during the 100 cycles but Pellet 6, having the thoriated tungsten clad, did crack. During an intermittent macroscopic examination after 35 cycles, the surface appeared dull and grainy as a result of extensive grain growth in the cladding. Then, after 50 cycles, the Zyglo test indicated apparent grain-boundary cracking almost identical to that observed during the previous thermal-cycle test with tungsten clads. Since the cracking appeared to be initiating on the exterior surface, thermal cycling of the pellet was continued. By the end of the 100 cycles, the entire clad surface was cracked, and some had propagated over the machined shoulder and into the thin end plug. Upon reaching the bond area between the clad tube and the end plug, the crack propagated circumferentially along the bond line.

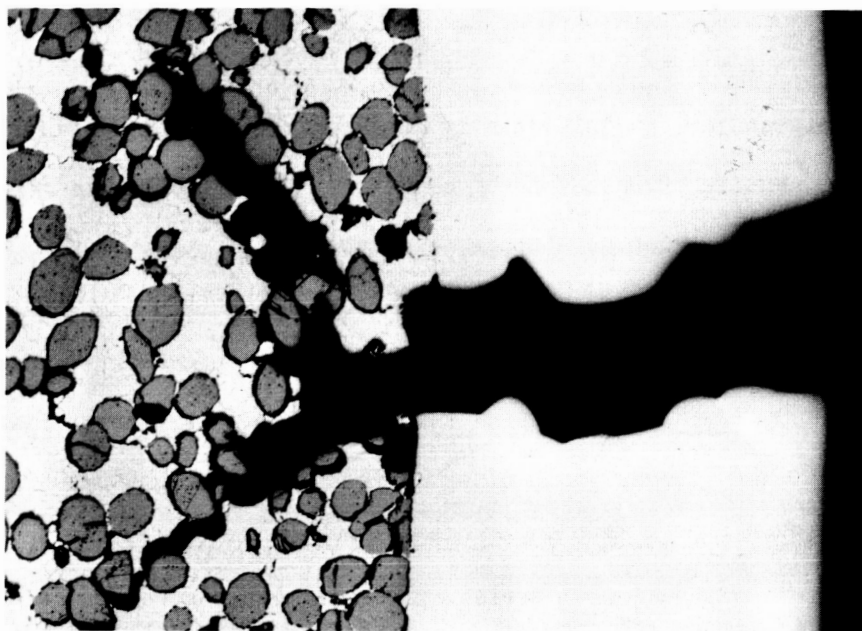
Figure 43 shows the two types of failures observed on the specimens. The top photo is of the "H" type crack which occurred in Pellet 11 at the thin eng-plug end. Notice that the end plug has bowed and that the crack protrudes

a. Thin End Plug Crack in Specimen 11

b. Typical Clad Crack in Specimen 15

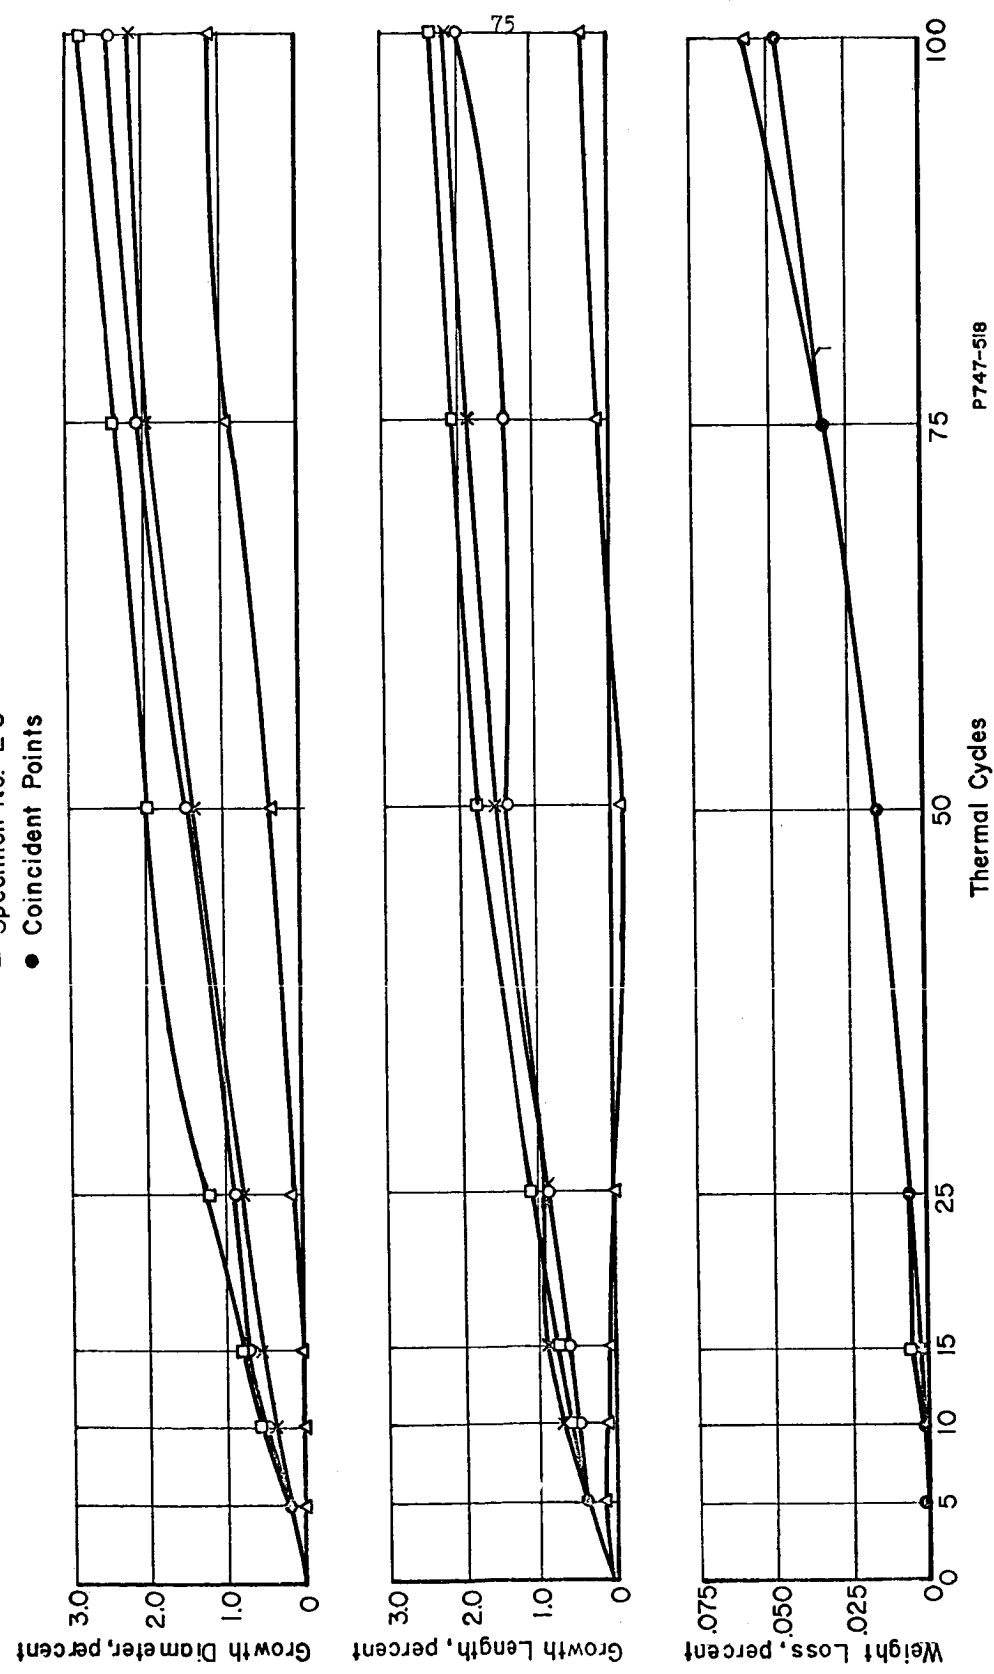
FIGURE 4.4. PERCENT GROWTH AND WEIGHT LOSS CURVES FOR ENRICHED THERMAL CYCLE SPECIMENS

- x Specimen No. E 4
- o Specimen No. E 5
- Specimen No. E 7
- △ Specimen No. E 8
- Coincident Points

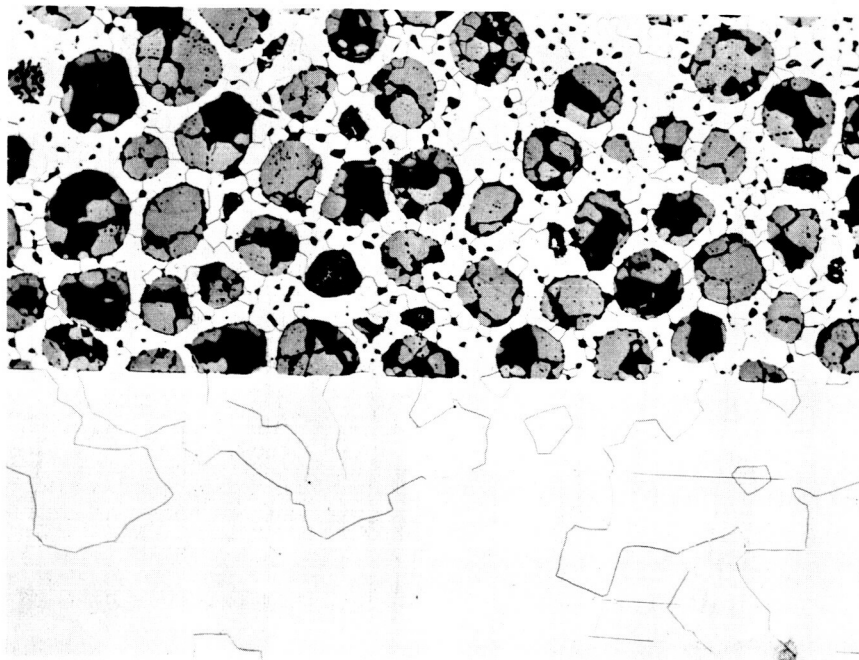
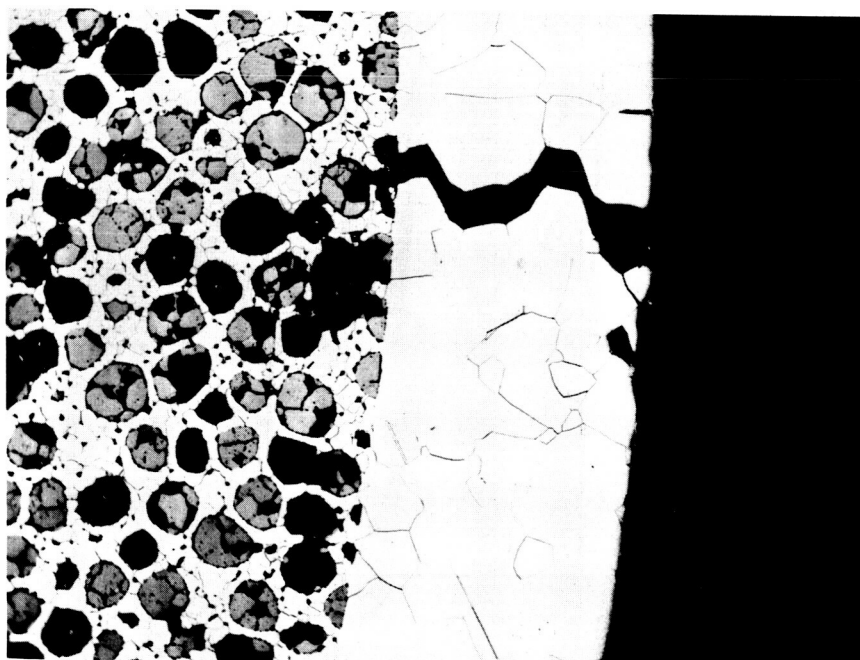
FIGURE 45. PELLETS E4 AFTER 100 THERMAL CYCLES

a. Clad and Core Structure

b. Fracture at Thin End of Pellet

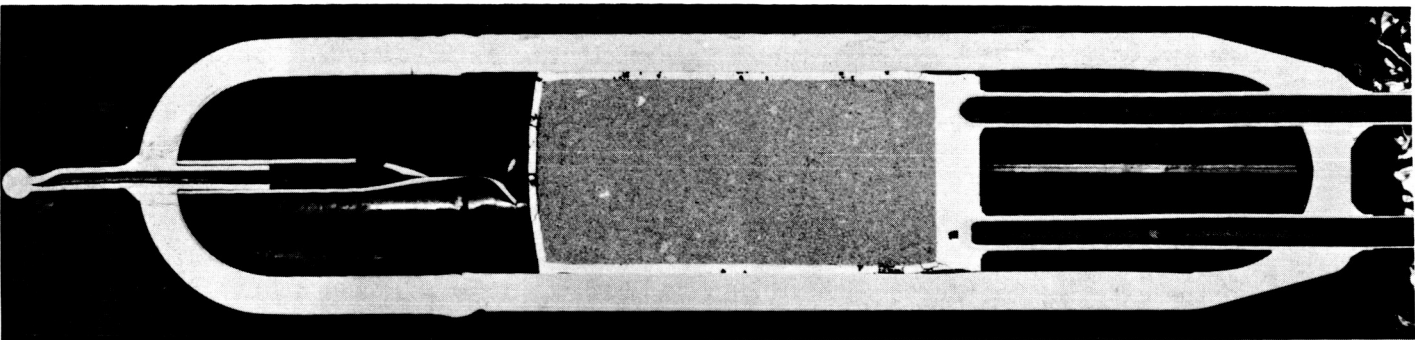
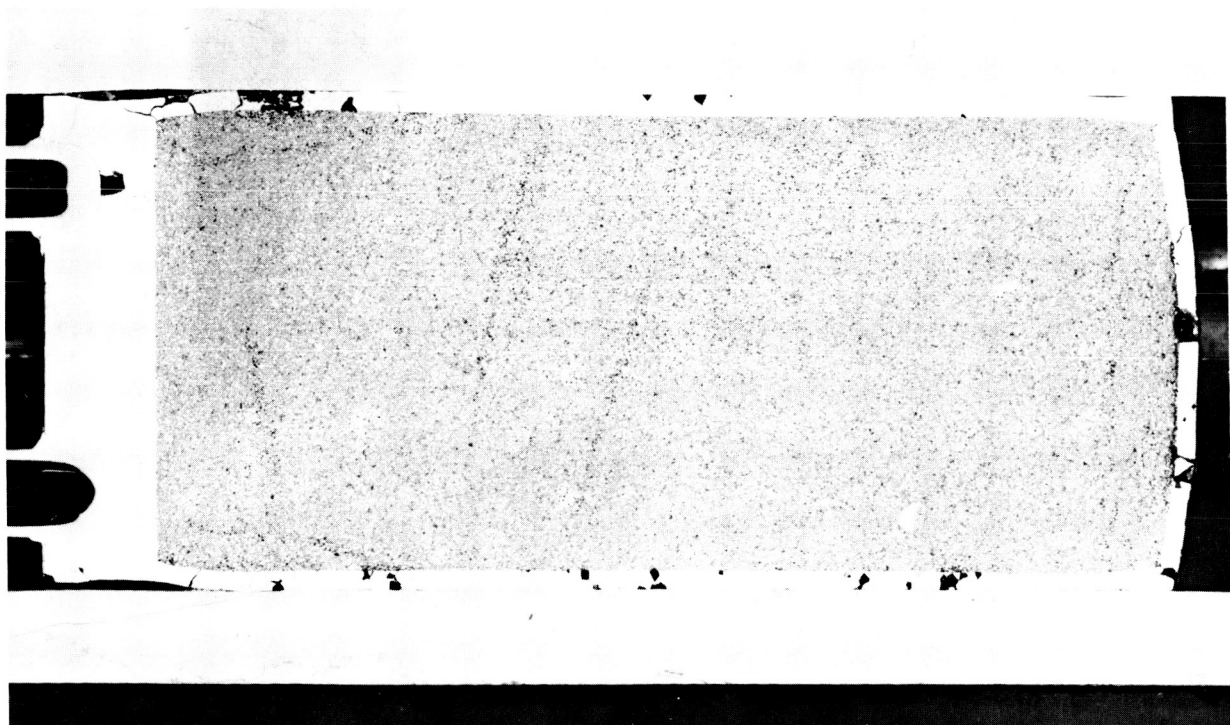
The mock-up containment vessel assembly was sectioned after thermal cycling. The pellet had grown about 4 percent on the diameter and about 4.8 percent in length. This growth was sufficient to cause contact between the clad pellet and the wall of the containment vessel. It was also evident that the positioning lugs at the thin end of the pellet had expanded into the wall of the vessel and had restricted freedom of movement of the pellet in the vessel. This is shown in Figure 50a. A photomacrograph of the clad pellet at higher magnification is shown in Figure 50b. This shows that the cladding of the fueled pellet cracked and chipped out easily during metallographic preparation.

a. Containment Vessel After Thermal Cycling

The results of this first thermal-cycle test of the containment vessel assembly indicated two areas that required further investigation. These were the growth characteristics of the fuel pellet in the assembly and an improved method of centering the pellet within the vessel. The lugs on the clad pellet, particularly on the end with the thin clad, expand into the vessel wall and restrict growth in the longitudinal direction.

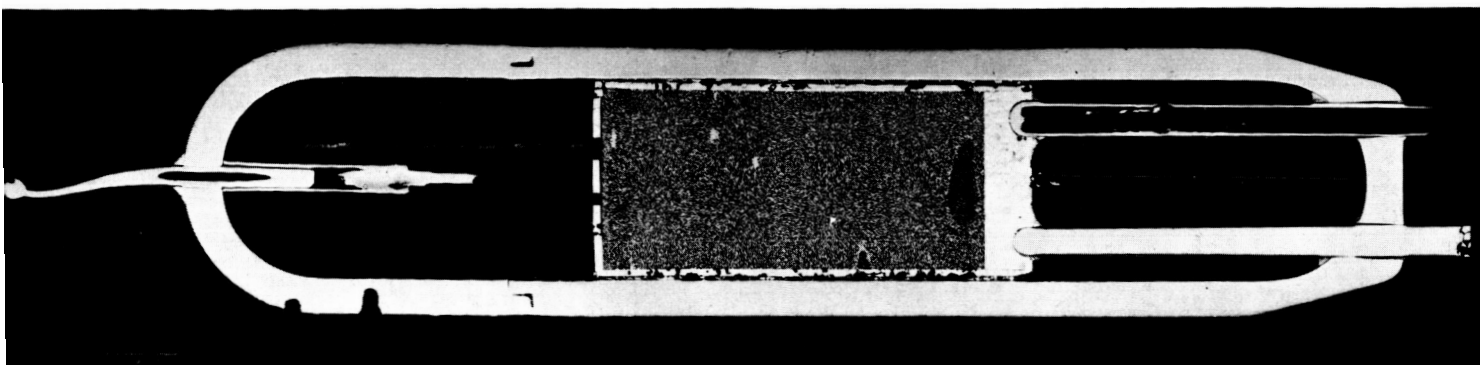
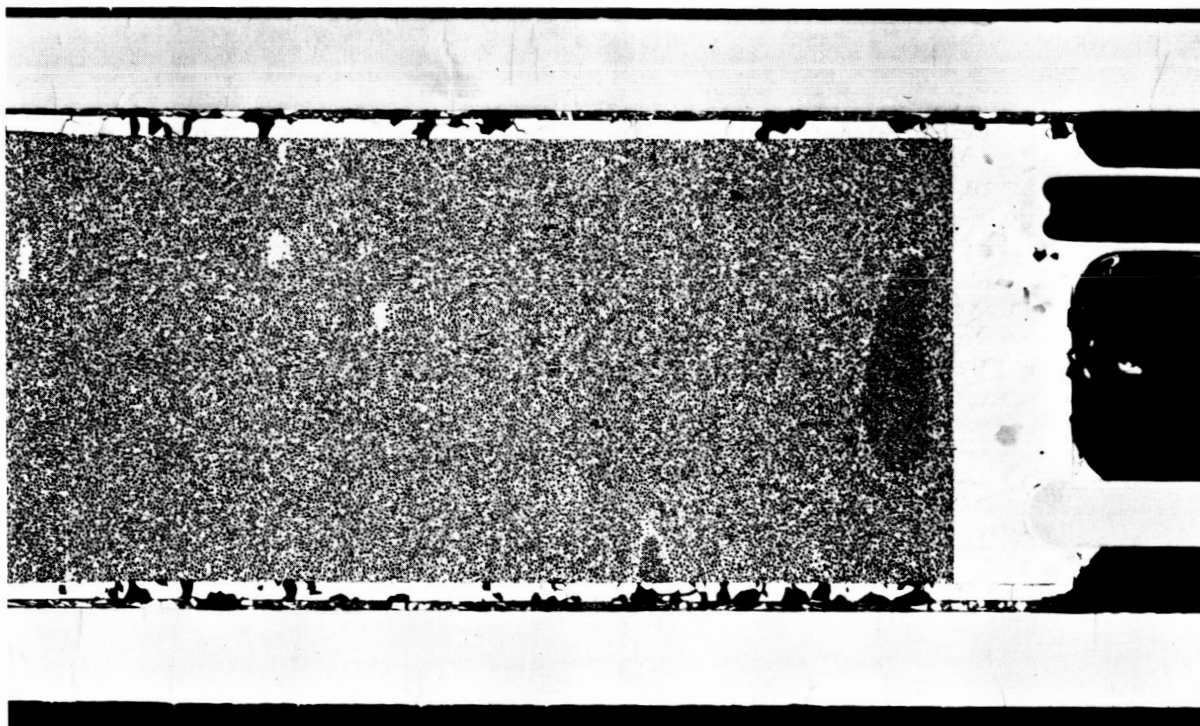
After 25 thermal cycles to 1770 K, the vessels were sectioned and examined metallographically. The pellet with positioning lugs on the thick end (Pellet E3) showed growth on the diameter of 1.2 percent and on the length of 1.7 percent. The values for the pellet with the positioning lugs removed from both ends (Pellet E10) had a 1.6 percent growth in diameter and a 1.7 percent growth in length. Metallographic examination of the sectioned vessels showed severe cracking of the tungsten clad; this appeared to be due to the sectioning operation. The other half of each pellet was removed from the vessel assembly and dye-penetrant inspected. Cracking was found to be adjacent to the sectioning plane. The remainder of the pellet, except for the heat checking on the thin end, appeared satisfactory. Photomacrographs of the vessel assembly containing Pellet E10 is shown in Figure 54. A separation between the thin end and the fuel form is very apparent. A poor bond between these two components probably existed

a. Containment Vessel After Thermal Cycling

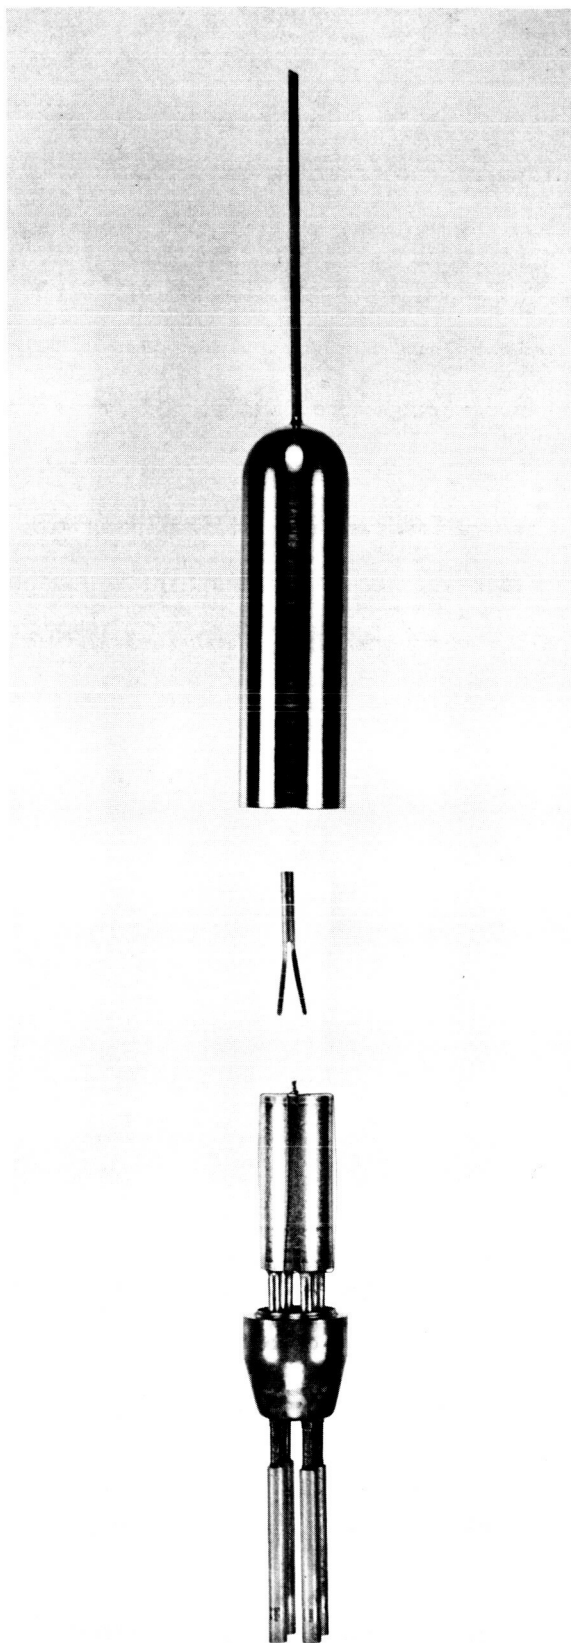
FIGURE 55. CONTAINMENT VESSEL MODIFICATION PRIOR TO WELDING

The modification proposed by NASA to provide a uniform clearance along the length of the fuel pellet is shown in Figure 55. The containment vessel was cut above the pellet and the two sections separated. The positioning lugs were removed by grinding and tantalum wire wrapped longitudinally along the pellet as shown. A new lower section of the tantalum-10 tungsten containment vessel was machined and the fill tube brazed into place. This procedure was accomplished for two of the vessel assemblies. The removal of the lower portion of the third assembly resulted in cracking of the clad on the fuel pellet. The fuel pellet in this vessel was brazed in one area to the vessel wall.

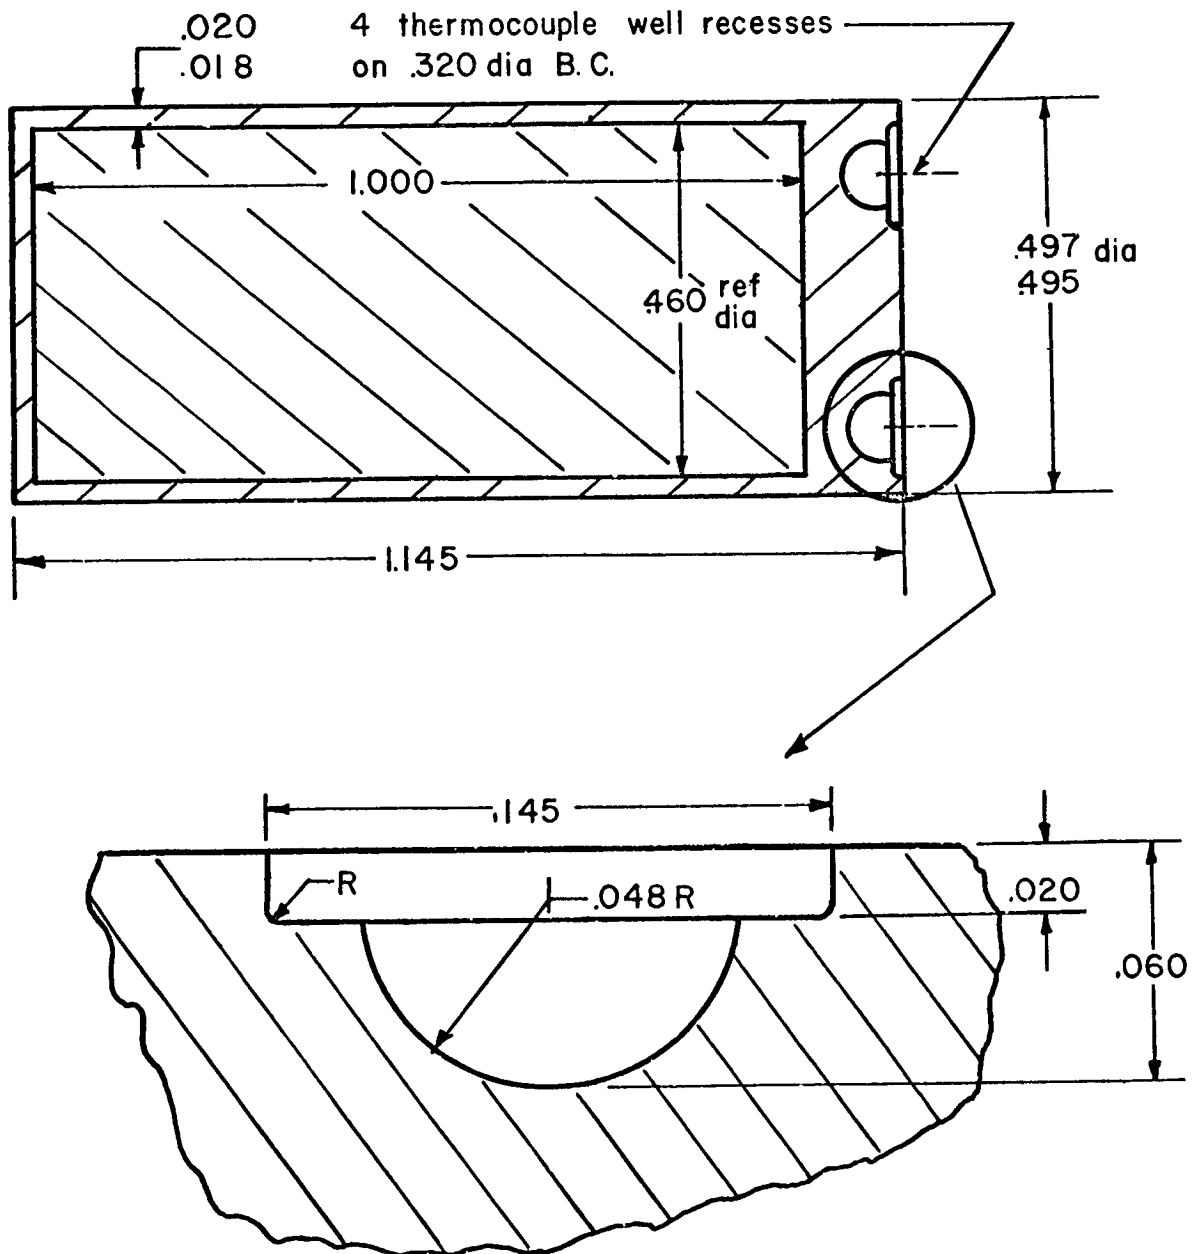
FIGURE 56. CLAD FUEL PELLET INCORPORATING MODIFIED RECESSES FOR THE THERMOCOUPLE WELLS

These three pellets, two of which had been re-clad were wire wrapped with tantalum wire and assembled into new containment vessel assemblies with new thermocouple wells and prepared for brazing. Excessively high temperature during brazing resulted in melting of the molybdenum boat used to contain the assemblies and resulted in loss of the three containment vessels. The pellets were removed and examined. Two of the pellets had pullout of grains on the thin end of the pellet. Attempts were made to patch these by densifying tungsten powder onto these ends by gas-pressure bonding. This approach was not satisfactory so the tungsten clad was removed by grinding and both pellets reclad. After the clad had been bonded, the pellets were machined and inspected.

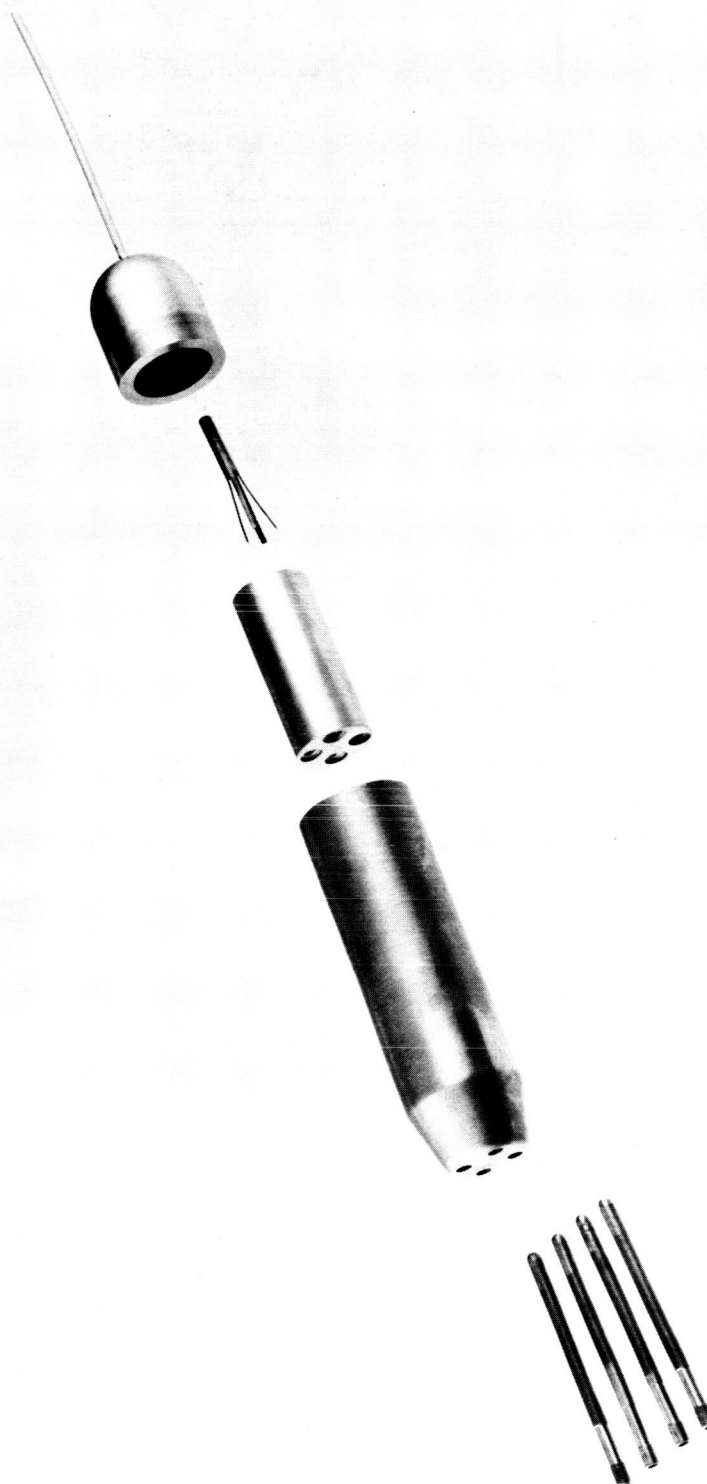
FIGURE 57. CONTAINMENT VESSEL COMPONENTS PRIOR TO ASSEMBLY

The clad fuel pellet is wrapped with tantalum wire prior to assembly.
